ELECTRO POLISHING FACILITY AT DESY

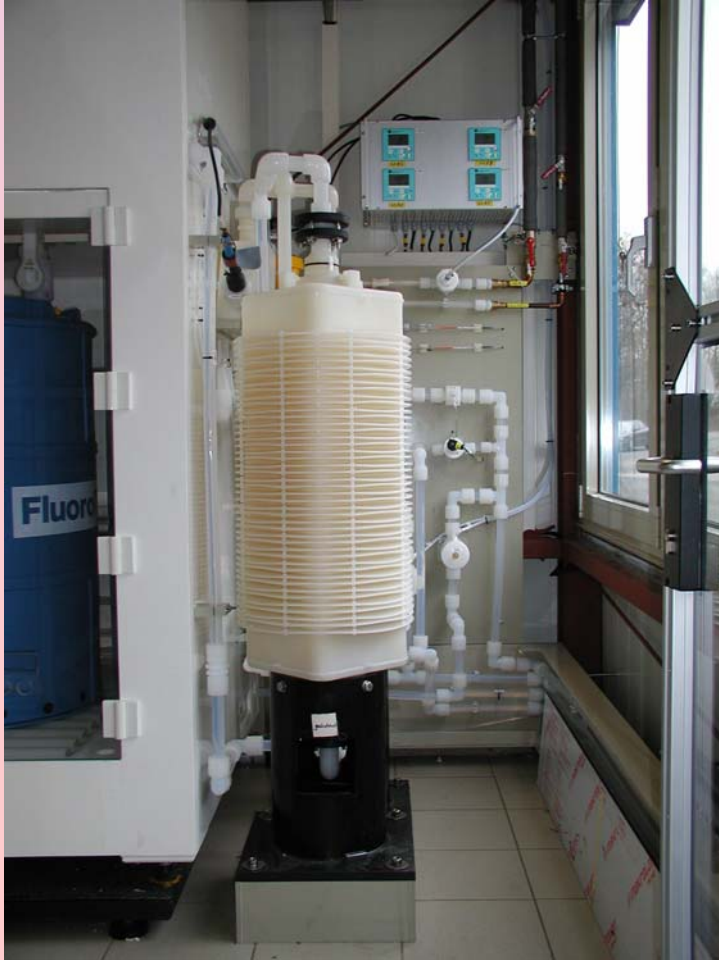
VERSION I

HEAT EXCHANGER

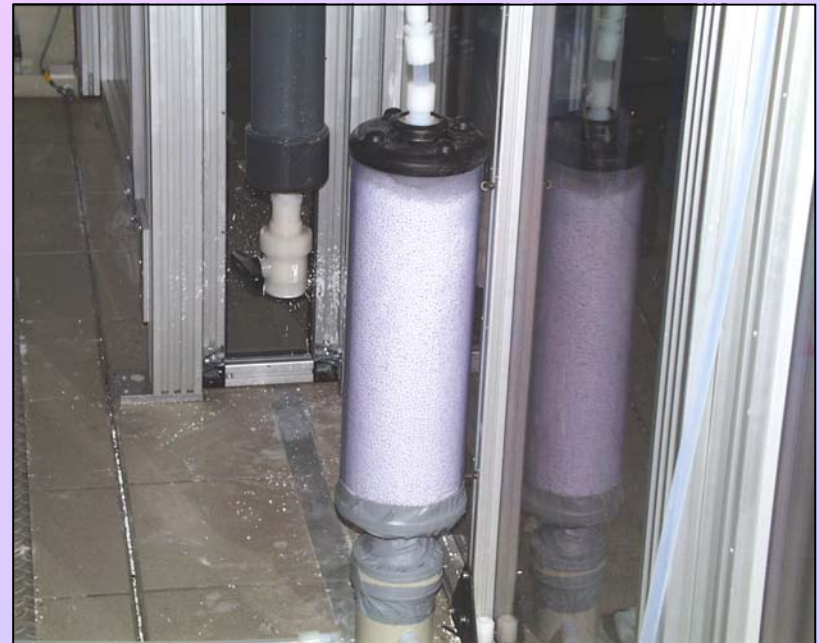
Advantage of the HF absorber opposite the gas scrubber and the lime milk cartridge

- The standard gas scrubber don't reduce HF-gas acceptable
- The lime milk cartridge has a very good absorb rate of HF but a high danger of a blockage of the cartridge
- The pressure fluctuations in the system are reduced with the HF absorber
- The HF absorb rate of HF absorber is good
- The danger of a blockage of the absorber cartridge is clearly smaller
- Changing of the granulates is simple

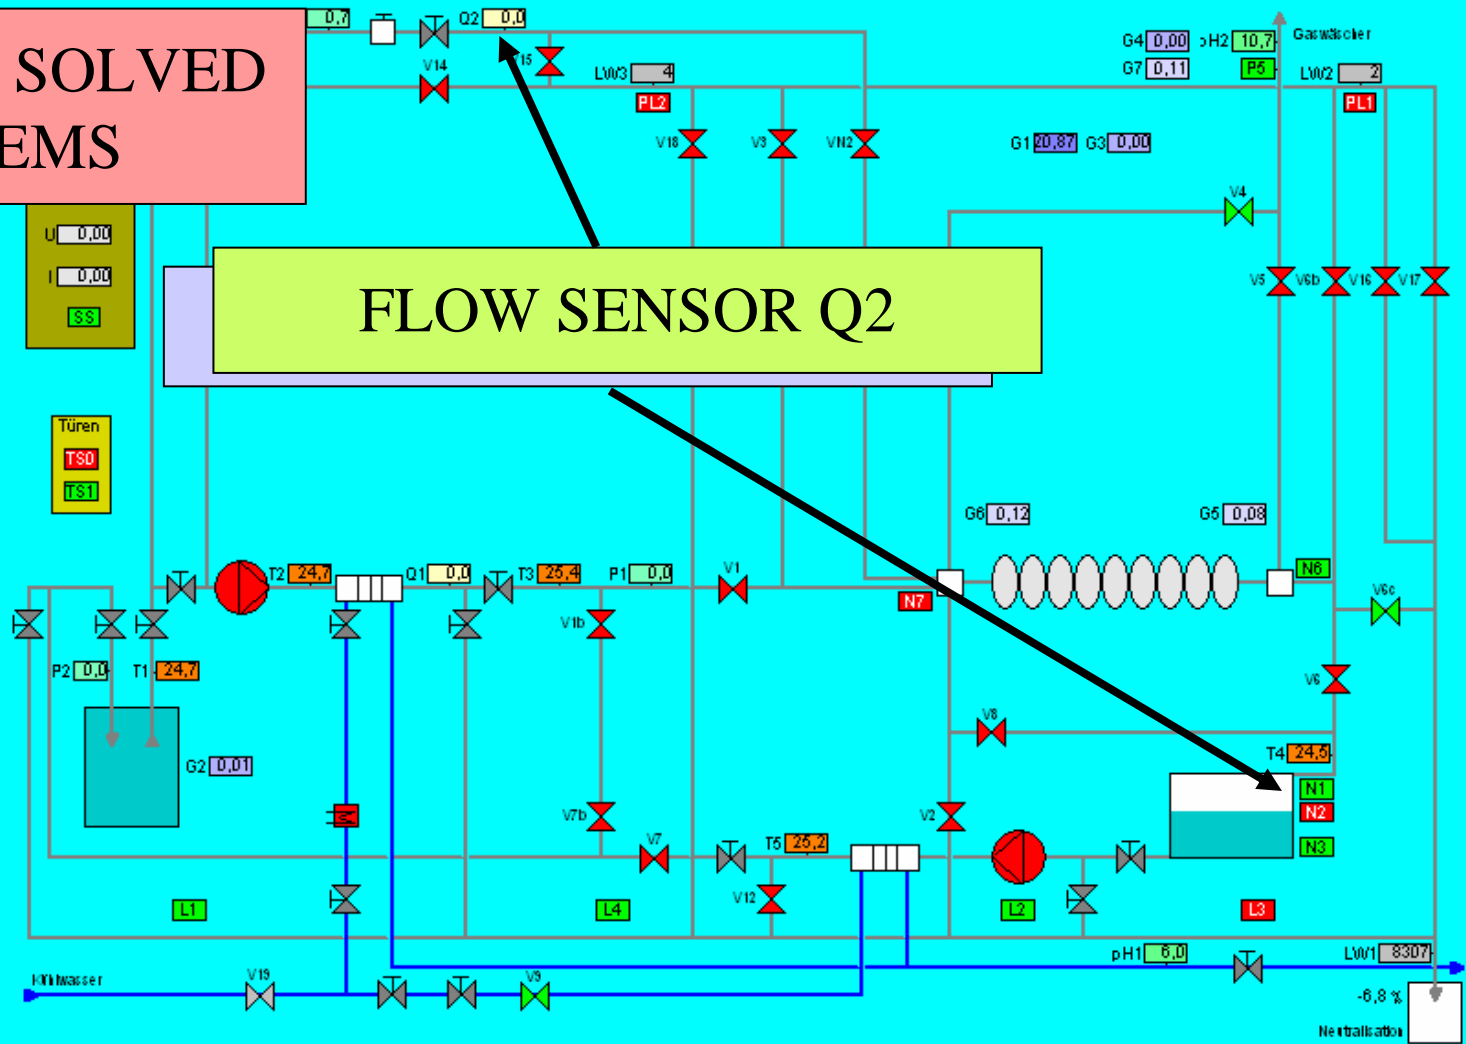
FLOW SENSOR Q2

OTHER SOLVED PROBLEMS
